88 Sinclair Street Kambah

Report Prepared:
6 May 2019

REPORT SUMMARY

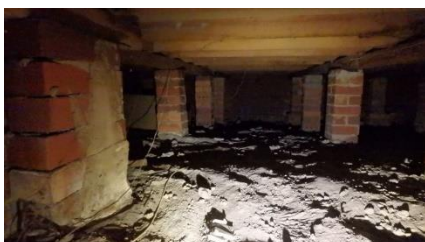
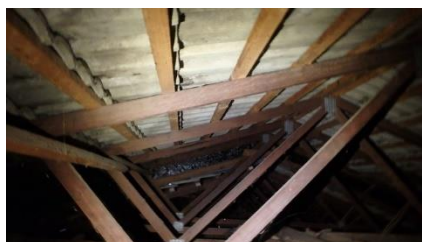
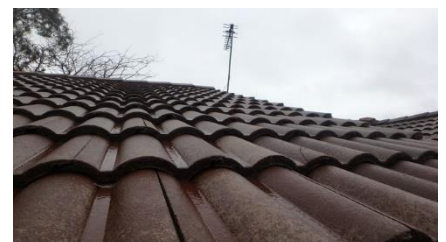
Where accessible, roof covering, roof cavity and subfloor images are featured below.
