Loose-fill Asbestos Insulation Ceiling Cavity Inspection Report

45 Baroona Avenue, Cooma, NSW 2630

Report number: 68447/2016/SAL/630-45_Baroona_Avenue_COOMA

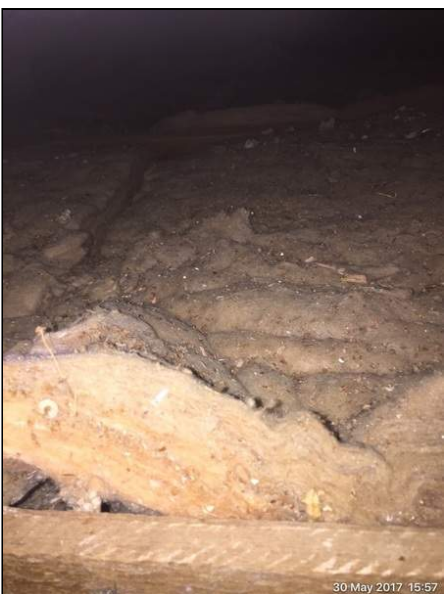
Photo Ref #3

Sample Number	Sample Reference	Sample Description	Location	Photo No.	Results
Sample 1	S105568/16.88_A01	Insulation Batt	Adjacent manhole	(Refer to photo 3)	No asbestos detected
Sample 2	S105568/16.88_A02	Loose Fill Insulation	Underneath yellow insulation batt	(Refer to photo 5)	No asbestos detected
Sample 3	S105568/16.88_A03	Ceiling Dust	Top of timber roof truss	(Refer to photo 7)	No asbestos detected

Sample 1 Location

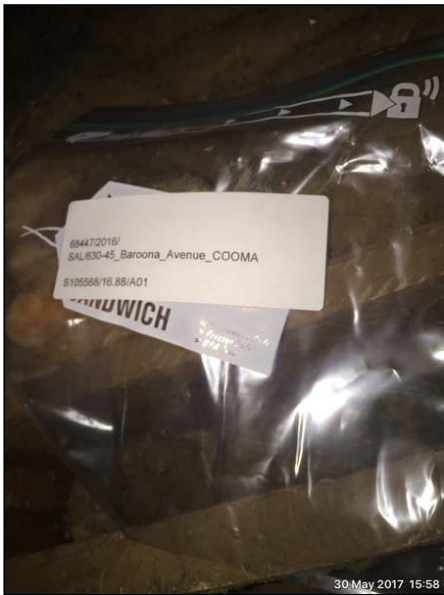
Photo Ref #4

Sample 1 Collected Sample

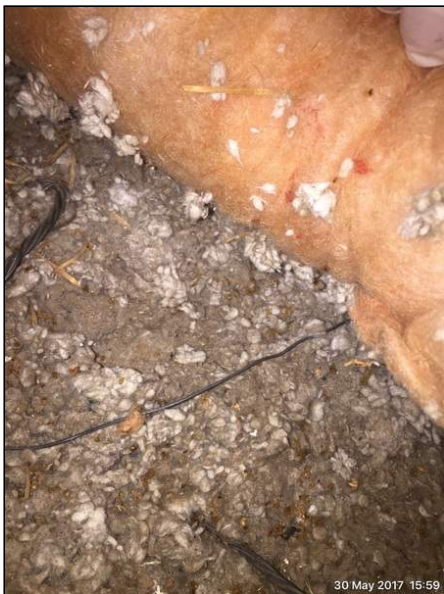
Photo Ref #5

Sample 2 Location

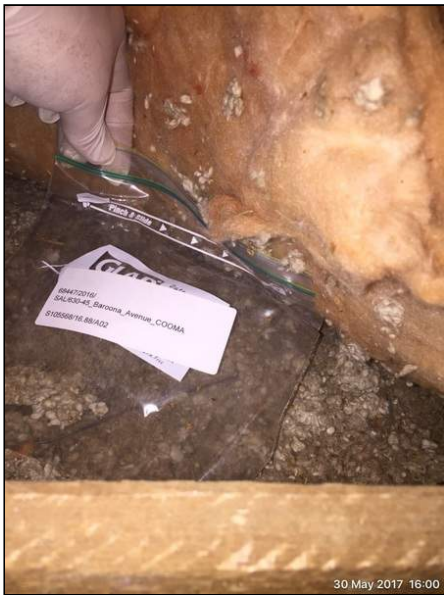
Photo Ref #6

Sample 2 Collected Sample

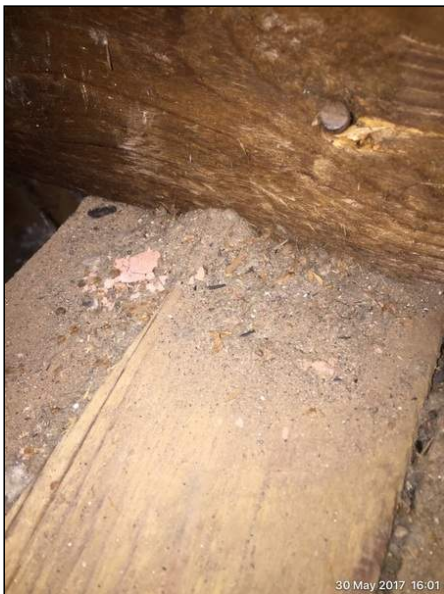
Photo Ref #7

Sample 3 Location

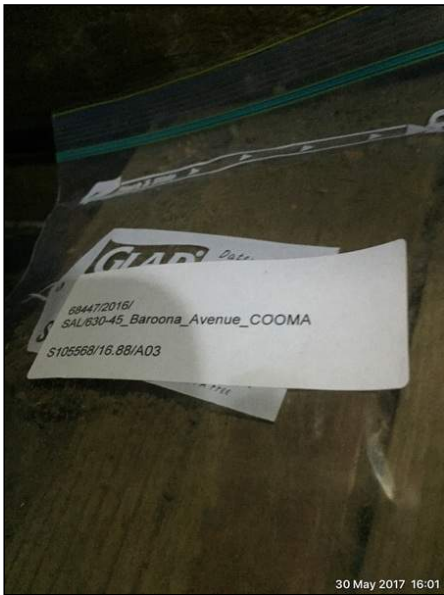
Photo Ref #8

Sample 3 Collected Sample
