ACT Property Report

- Building Report
- Compliance Report
- Timber Pest Inspection Report
- Energy Efficiency Rating
- Conveyancing Report
- Insurance Certificates
- Invoice

24 HARPUR PLACE GARRAN ACT 2605

Report Prepared: Tuesday, 29 October 2013

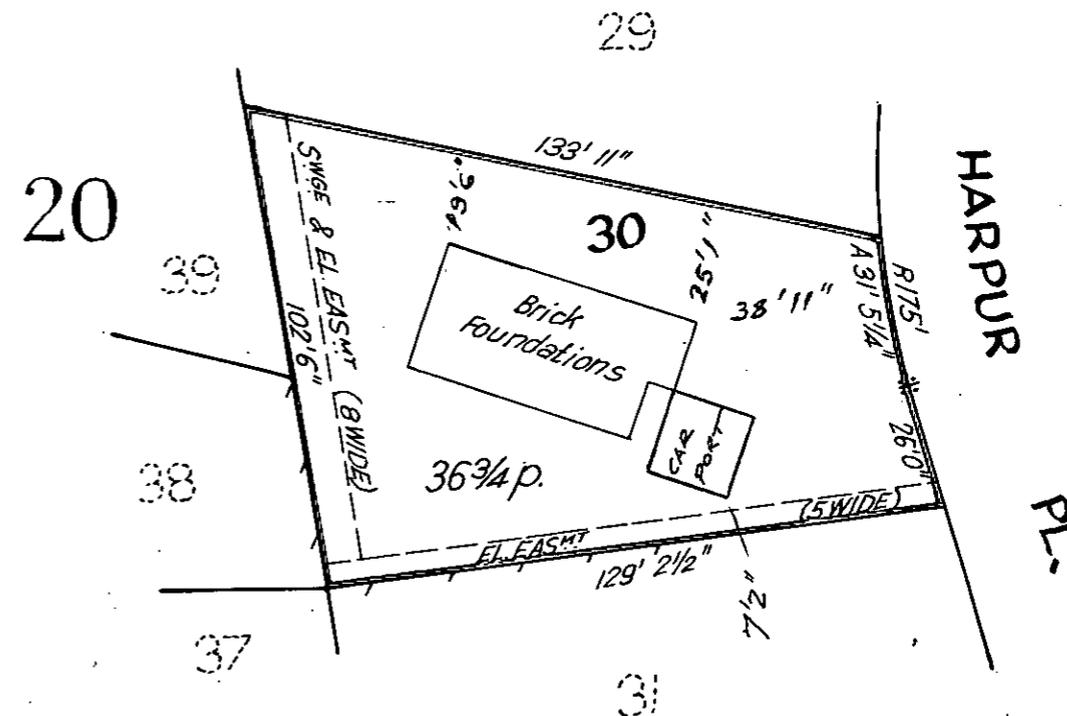
SKETCH

Scale 40 feet to an inch

Cottage now completed.
CAR PORT ADDED.

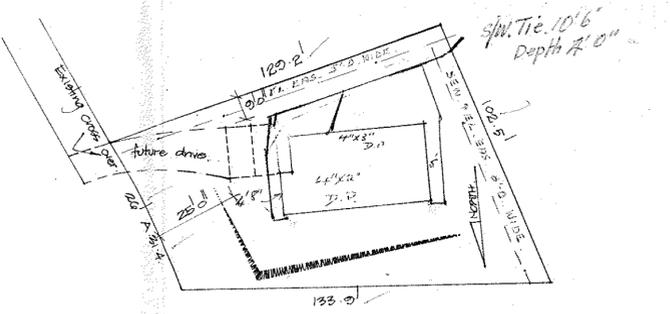
SITE PLAN. SCALE 40' to 1"

A check survey is to be lodged at the Building Section and no work on this project is to proceed above ground level without prior approval.

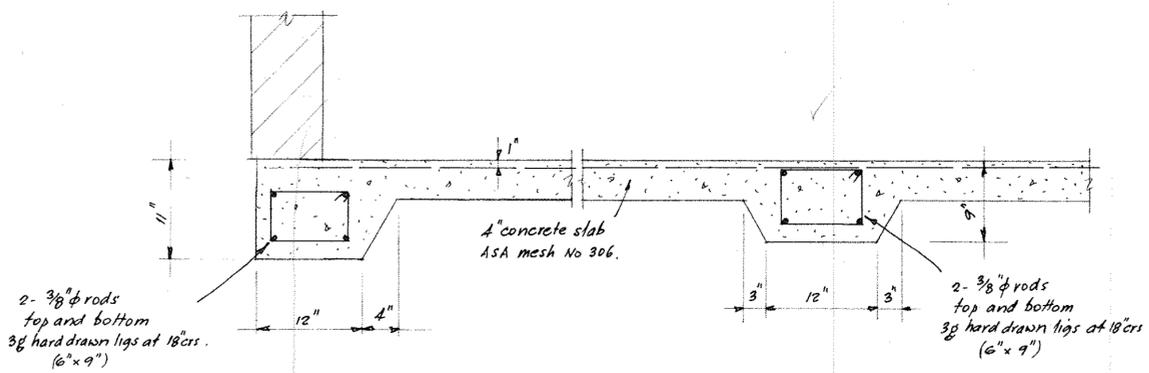
TYPICAL EXTERNAL RIB R1.

TYPICAL INTERNAL RIB R2.

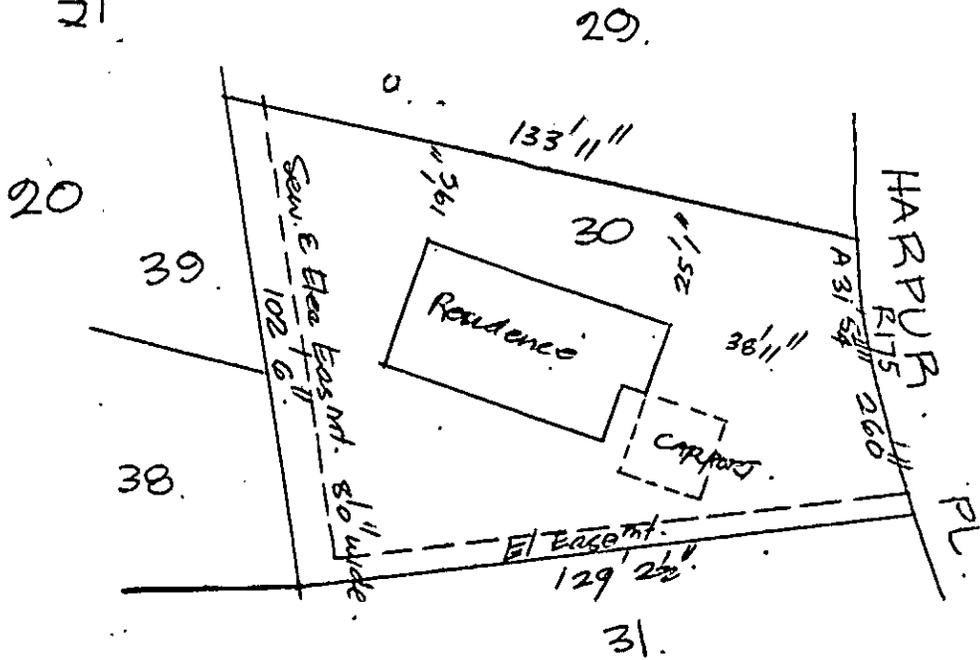
Continued 26/5/67
 REVISED SITE PLAN

RESIDENCE FOR MR & MRS BUTLER
 30/20 GARRAN ACT.
 AMENDED DRAINAGE PLAN REQUIRED
 DOUGLAS BUILDING & DESIGN GROUP
 PO BOX 742 CANBERRA CITY ACT.

BLOCK 30 SECTION 20. GARRAN.

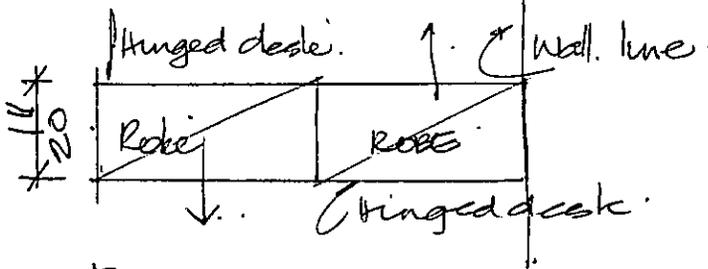
PLAN.

SCALE 1/4" = 10"
