# 1 Amaryllis St, Wright ACT 2611 Report prepared: Monday, 21 October 2019

Building Report Compliance Report Timber Pest Inspection Report Conveyancing Report Energy Efficiency Rating Insurance Certificates Tax Invoice

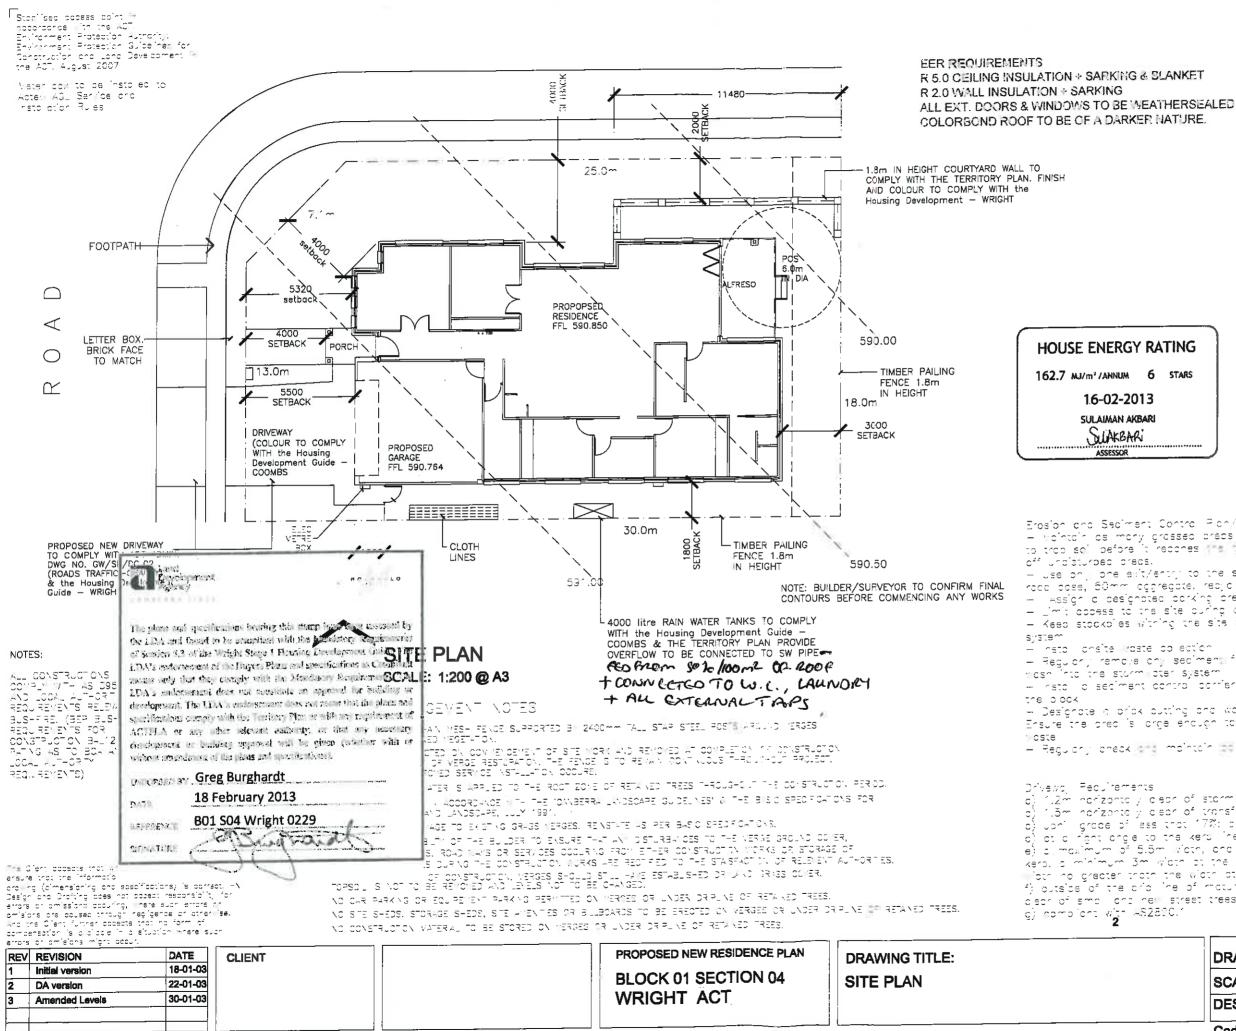
27.	the front op. the front op. th ot kero	incory, and	a maximum	
	noture trees. trees	ond a minir	2 1	881
	DRAWING I	No: 01	DATE: 3	0-01-03
	SCALE: AS	SHOWN	DRAWN	BY: HN
	DESIGN BY	':	SHEET 0	1 OF 06

BLOCK AREA:	527.0m <sup>2</sup>
LIVING AREA	200.0m <sup>2</sup>
GARAGE	40.0m <sup>2</sup>
TOTAL:	240m <sup>2</sup>
PORCH	2.6m <sup>2</sup>
ALFRESCO	8.5m <sup>2</sup>

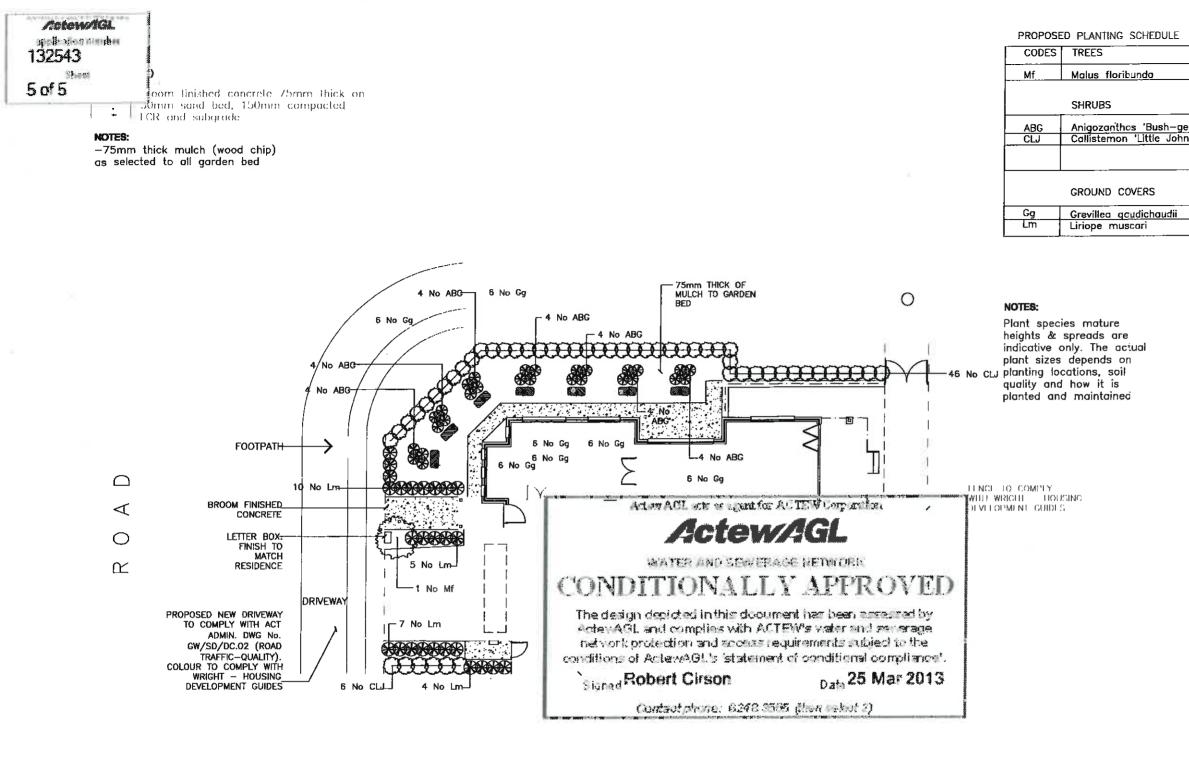
REV 1	REVISION Initial version	DATE 15-01-03 22-01-03		PROPOSED NEW RESIDENCE PLAN BLOCK 01 SECTION 04	DRAWING TITLE:	DRAWING No: 05	DATE: 18-03-03
3	DA version Amended Levels Amended Courtyard walls	30-01-03 18-03-03		WRIGHT ACT	LANDSCAPE CONCEPT	SCALE: AS SHOWN DESIGN BY:	DRAWN BY: HN SHEET 05 OF 06

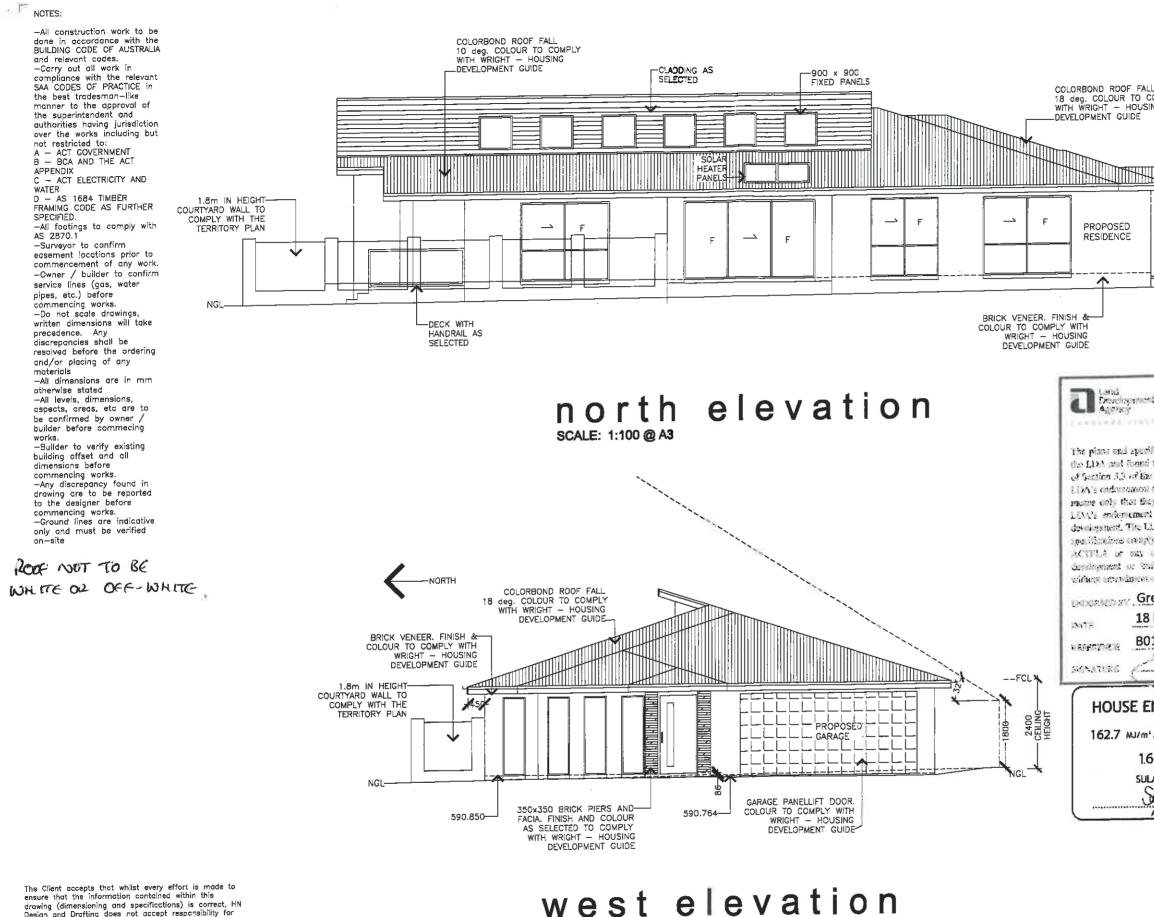
r	REV         REVISION           Initial version         DA version           Amended Levels         Amended Levels	DATE 15-01-03 22-01-03 30-01-03	CLIENT	PROPOSED NEW RESIDE BLOCK 01 SECTION WRIGHT ACT	I	DRAWING TITLE: ELEVATIONS	
F						<del>_</del>

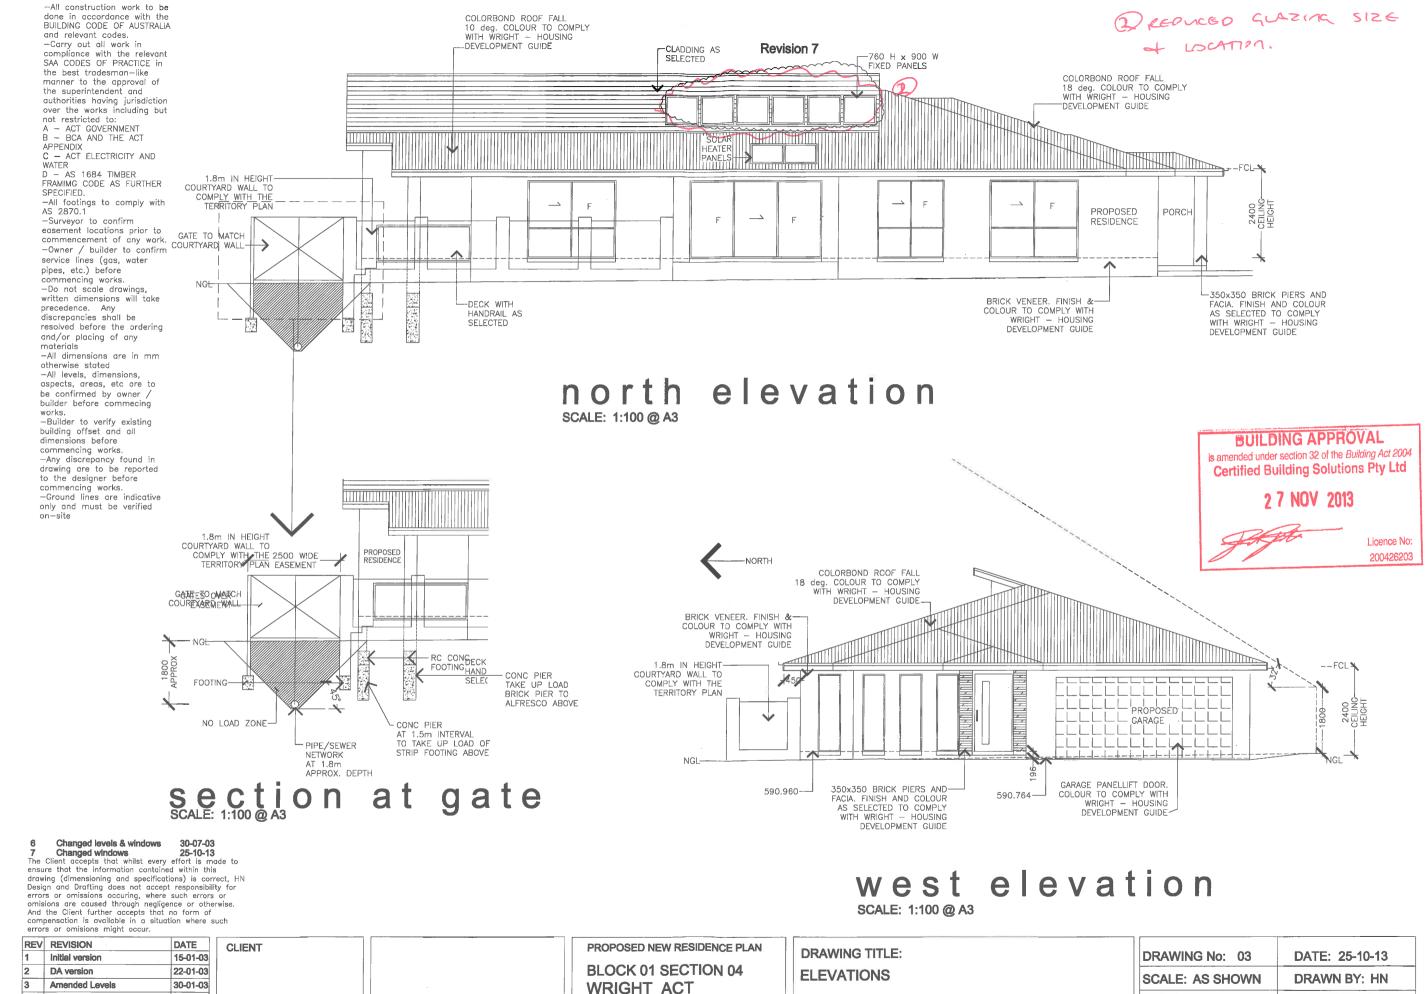
DRAWING No: 03	DATE: 25-10-13		
SCALE: AS SHOWN	DRAWN BY: HN		
DESIGN BY:	SHEET 03 OF 06

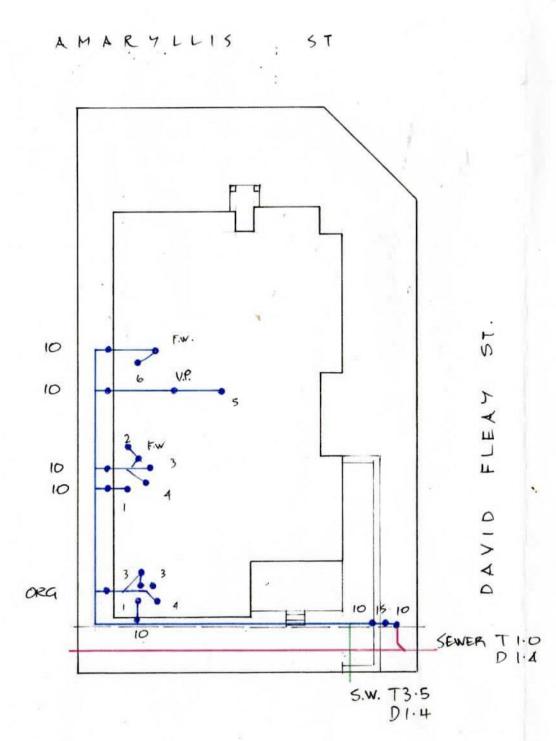
# PLAN OF SANITARY DRAINAGE

- 1. Drains to be laid shown in BLUE lines.
- 2. Existing drains shown in GREEN lines.
- 3. Existing drains X'ed in RED to be abolished to approval.
- 4. Drains to be supported on or from solid ground.
- Copper pipes to be in a accordance with AS.1432-1973 Table 2 Type B tubes. 5.
- 6.
- 7. Drains under Building must be retested, if test failed then old drain must be replaced using either RRJVCP or UPVC pipe material.
- 8. Sewer branch to be located on site before any work is commenced.
- 9. This plan to be read in conjunction with approved Architectural Plans and Specifications.
- 10. ORG levels to be read in conjunction with AS 3500.2 Clause 4.6.6.6 and 4.6.6.7

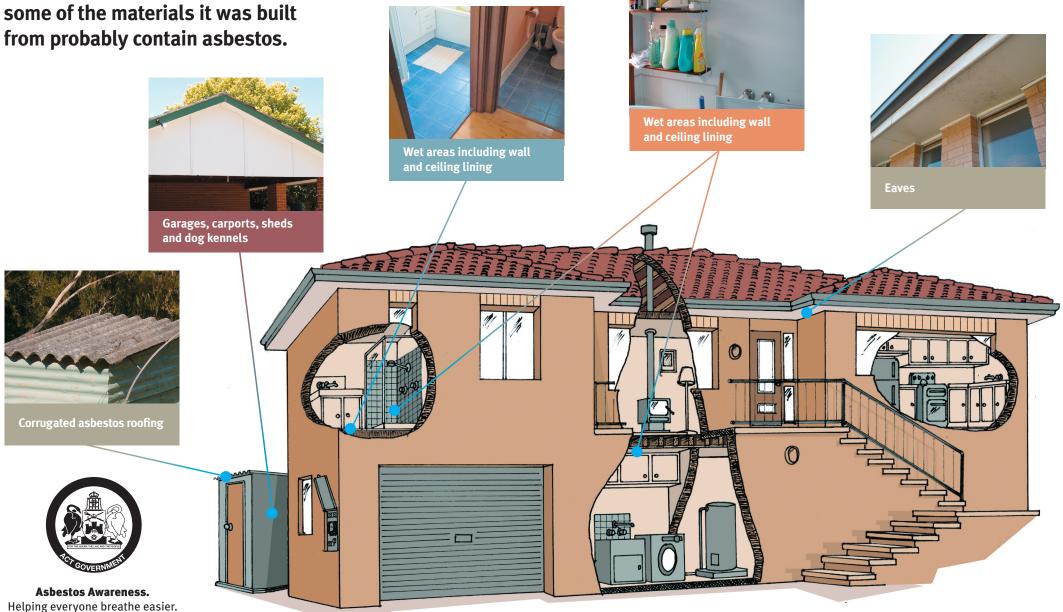
# **Common locations of materials containing asbestos in ACT homes**

If your house was built before 1985, some of the materials it was built

- If your house was built before 1985, the table below gives you an indication of where you are likely to find MCAs in your home. There is also a diagram on the back of this sheet showing where MCAs are commonly found.
- If your house was built after 1985, it is unlikely to contain MCAs.
- If in doubt, assume that materials DO contain asbestos.
