## FIRST CALL PROPERTY INSPECTIONS

**11 Khull Crescent  
Kambah ACT 2902**

## **Standard Property & Timber Pest Report**

## STANDARD PROPERTY & TIMBER PEST REPORT in accordance with AS 3660.1 - RSA form C3 - 4/3/15 edition

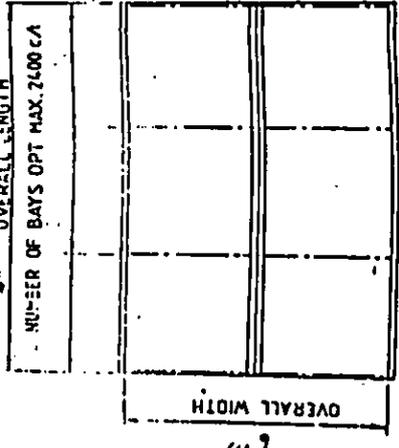
PLAN R.T.S.

SIDE VIEW

CHORDS 45x45x3 ANGLE LAP & WELD AT RIDGE & ENDS EAVE. WELDS 300mm MIN. LENGTH WEBS 120 BAR

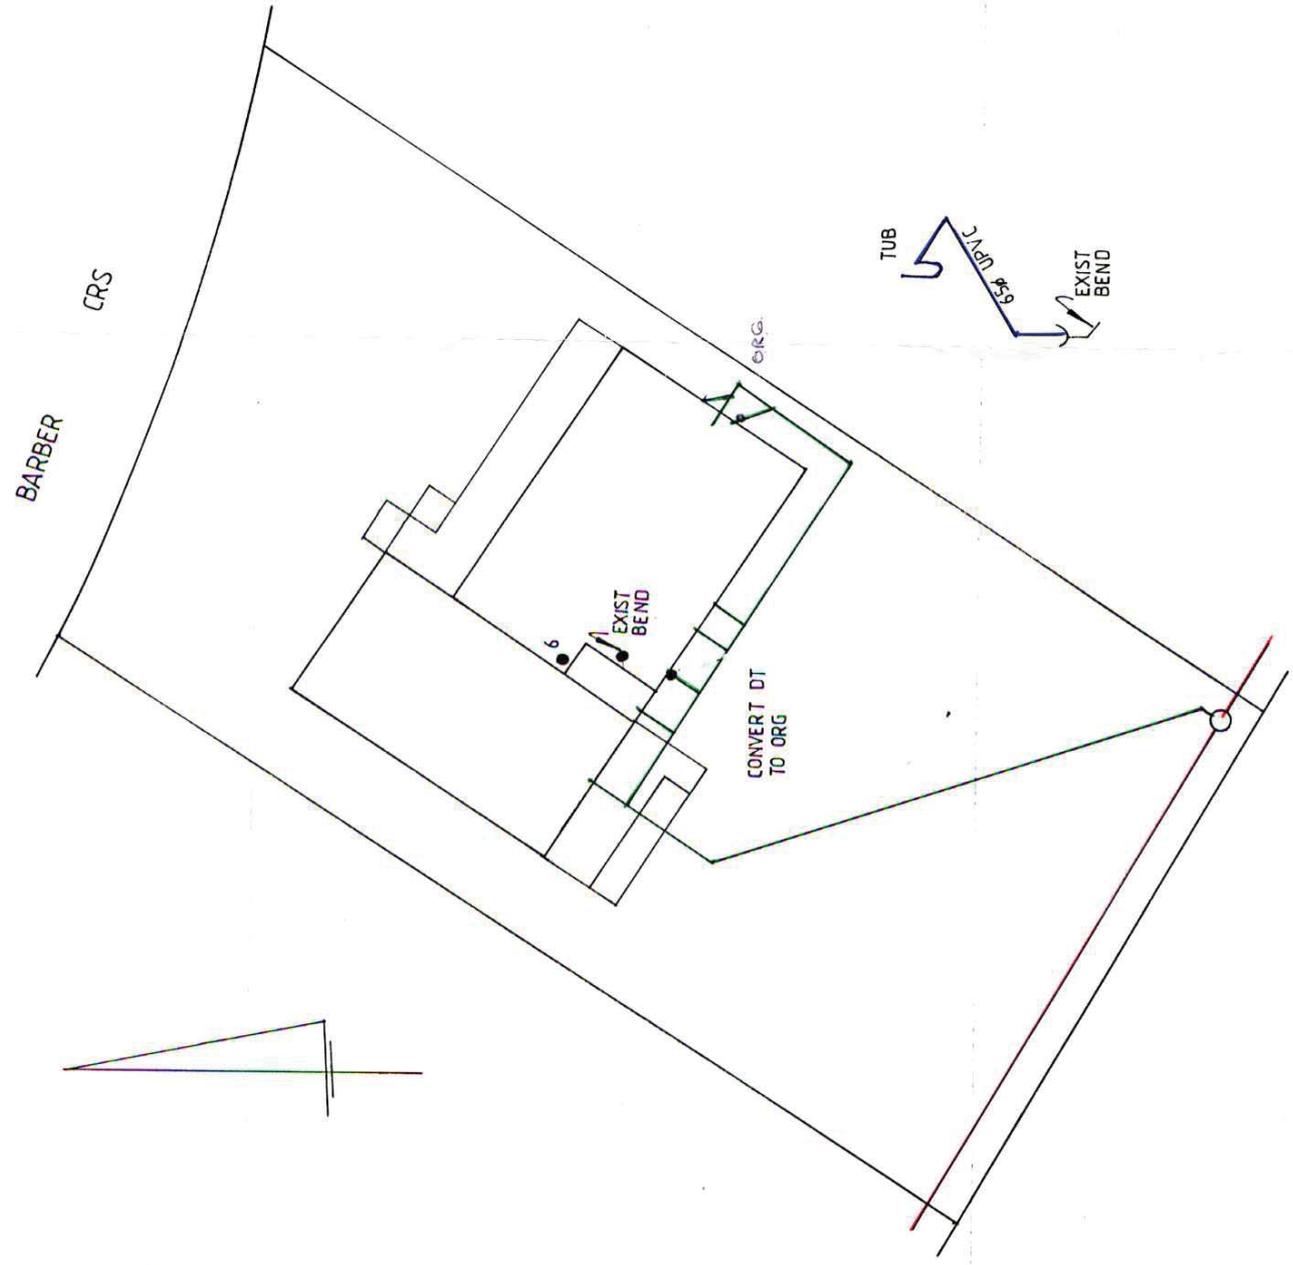
All work must be carried out in conformity with the Camberra Sewerage  
And Water Supply Regulations

Designed to as 3500
