Report

Building Report Residence 1

CONCLUSION AND SUMMARY – RESIDENCE 1

Compliance Report Residence 1 & 2

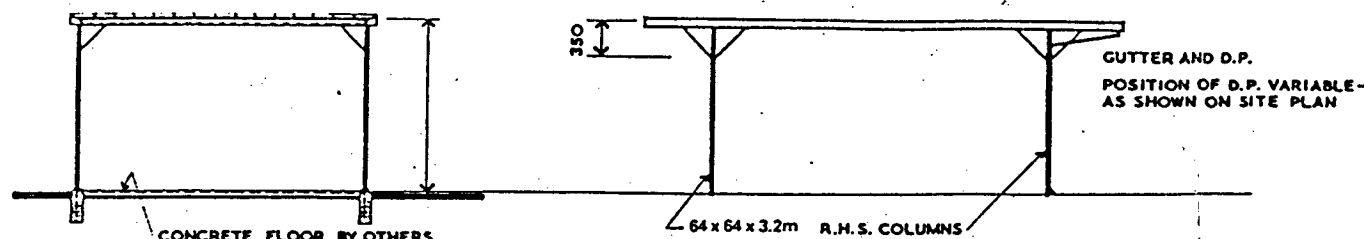
SECTION

LYSAGHT TRIMDECK OR MONOCLAD ROOFING

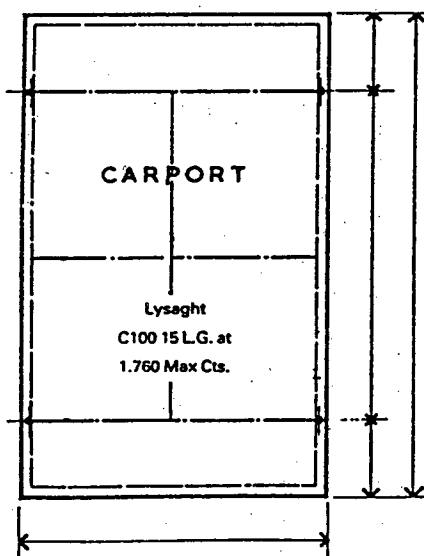
PLAN
(TYPICAL)

TO BE PRECOLOURED TO MATCH THE
PREDOMINANT COLOUR OF THE EXISTING
RESIDENCE

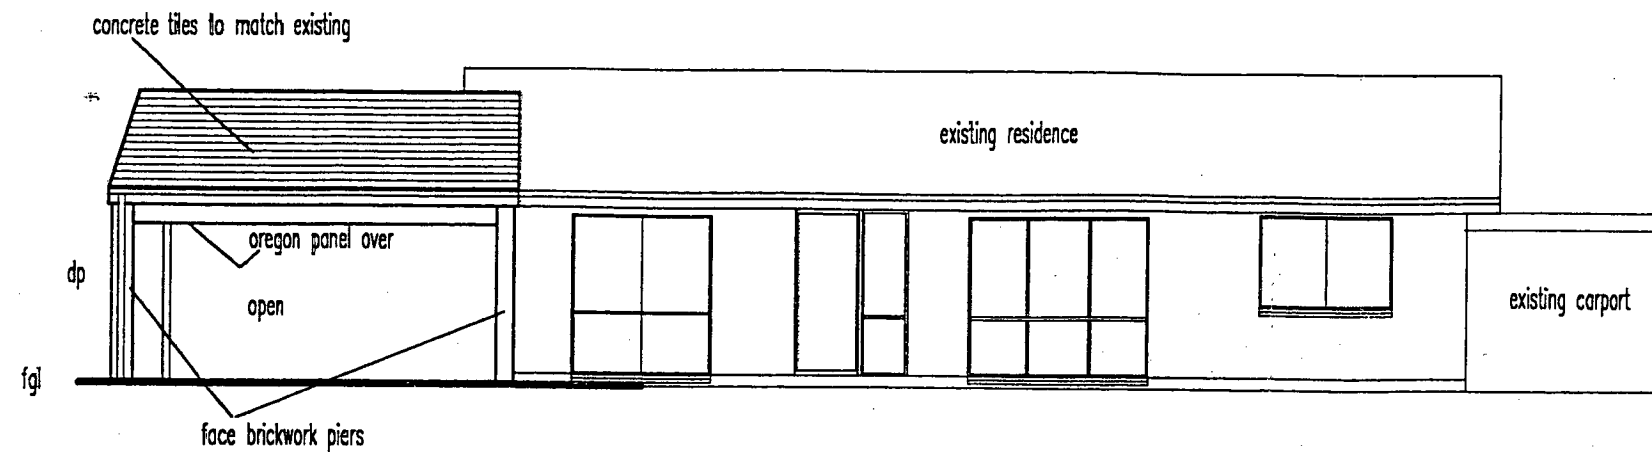
FRONT ELEVATION 1.100

area 28.76m²

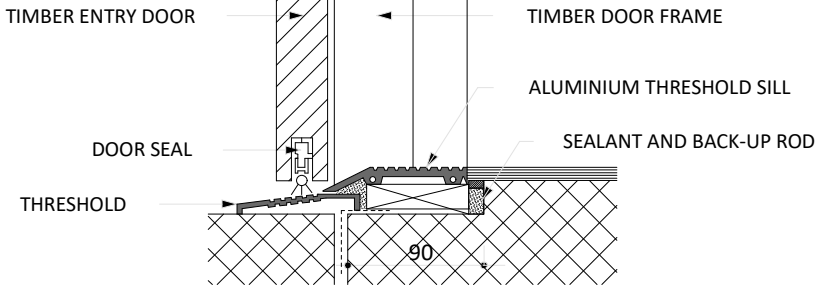
ACCESSIBLE ENTRY SECTION
SCALE 1:5

110. Door hardware operable with one hand, located 900-1100 mm above floor

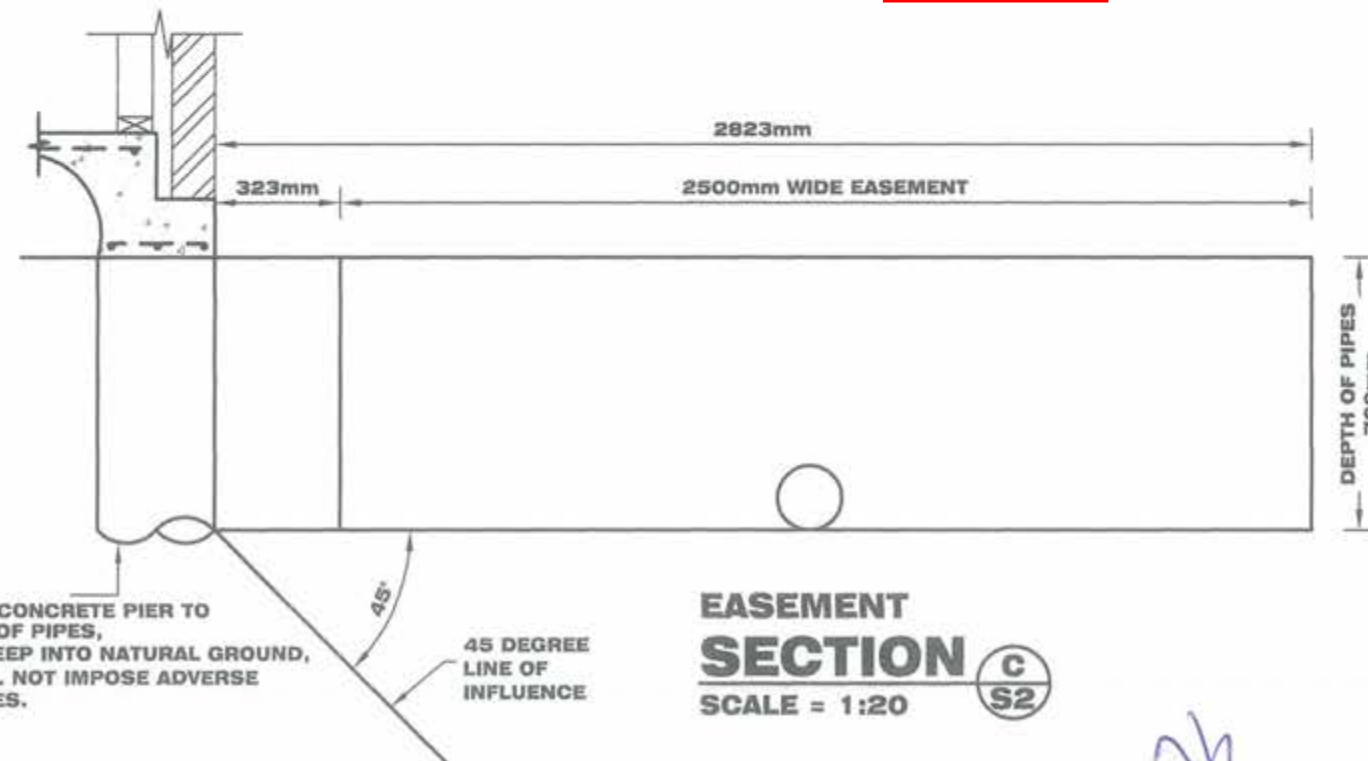
Ø 300mm DIA CONCRETE PIER TO INVERT LEVEL OF PIPES, MIN 700mm DEEP INTO NATURAL GROUND, FOOTINGS WILL NOT IMPOSE ADVERSE LOADS ON PIPES.

45 DEGREE LINE OF INFLUENCE
