### 29 Gamor Street WARAMANGA ACT

Date of Inspection: Wednesday 2<sup>nd</sup> October 2019

## **Pre-Purchase Inspection - Residential Building Report – (ACT)**

**Complies with Australian Standard AS 4349.1- 2007 Inspection of Buildings Part 1:  
Pre-Purchase inspections – Residential buildings – Appendix “C”**

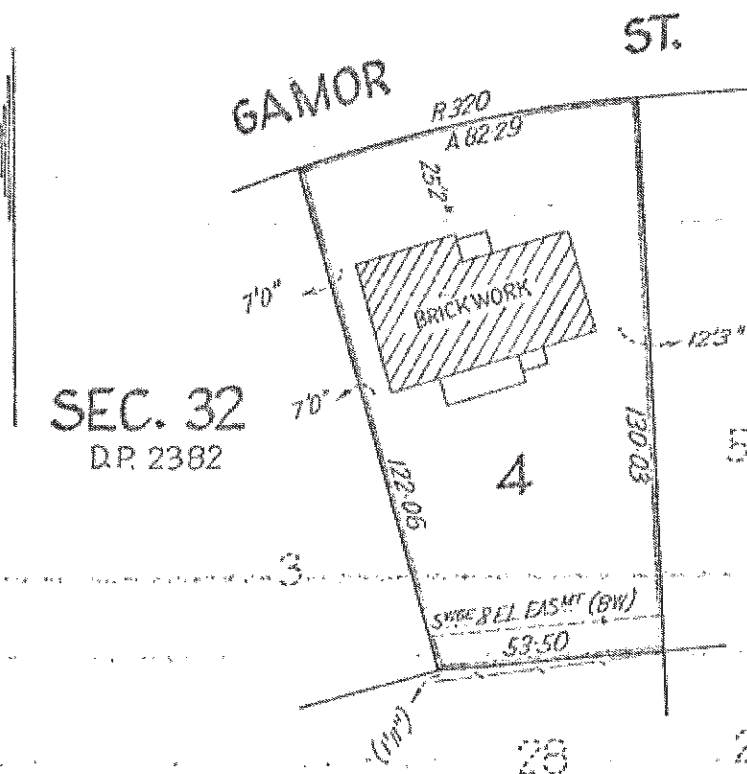
Apparent easements affecting the subject land are as shown. Fencing on or near the boundaries is as shown on the sketch.

Other than as shown on the sketch, there are, in my opinion no encroachments by or upon the subject land.

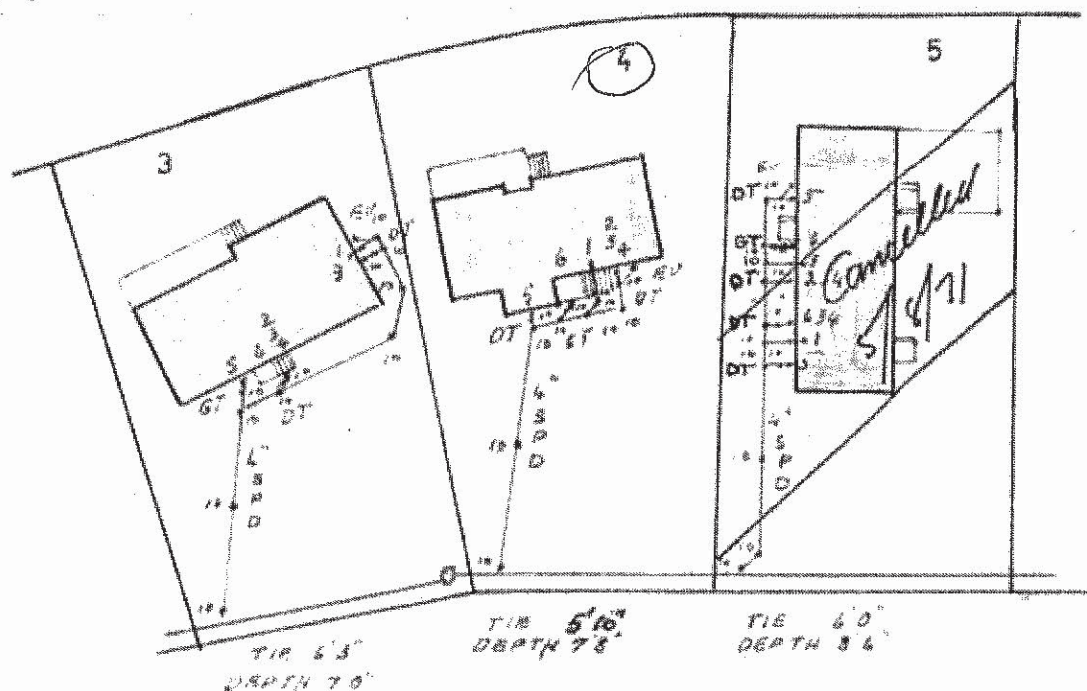
1. WATER CLOSET.
2. BATH.
3. BASIN.
4. SHOWER.
5. SINK.
6. TROUGHS.

NOTES ——— DRAINS TO BE LAID ARE SHOWN IN BLUE LINES.

THIS PLAN TO BE READ IN CONJUNCTION WITH APPROVED ARCHITECTURAL DRAWINGS AND SPECIFICATIONS.

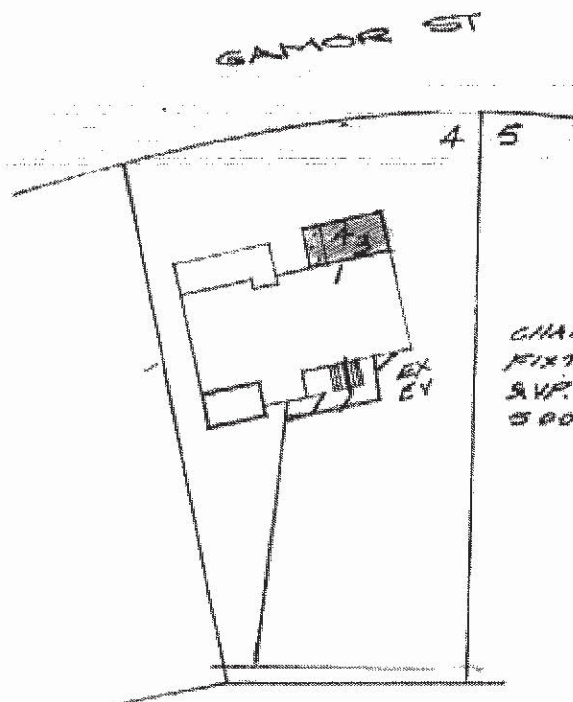
1.	WATER CLOSET	( / )
2.	BATH	( )
3.	BASIN	( / )
4.	SHOWER	( / )
5.	SINK	( )
6.	TROUGHS	( )

CHANGE EV TO EVF.  
 FIXTURES TO CONNECT TO  
 SVP. & BE VENTED WITHIN  
 300 OF THE TRAP

NOTES: DRAINS TO BE LAID ARE SHOWN IN BLUE LINES. THIS PLAN TO BE READ IN CONJUNCTION WITH APPROVED ARCHITECTURAL PLANS AND SPECIFICATIONS.  
 DRAINS TO BE DELETED SHOWN BY RED X. EXISTING DRAINS SHOWN IN GREEN LINES.  
 POSITION OF BRANCH TO BE LOCATED BEFORE ANY WORK IS COMMENCED.  
 DRAINS TO BE LAID IN (U.P.V.C.) UNPLASTICISED POLYVINYL CHLORIDE IN ACCORDANCE WITH A.S.A. CA 67 1972 AND CANBERRA CODE OF PRACTICE ISSUE 1 JULY 1974.
