**31 Banfield Street  
Downer**

Report Prepared: 31 October 2019

**PRESALE REPORT**

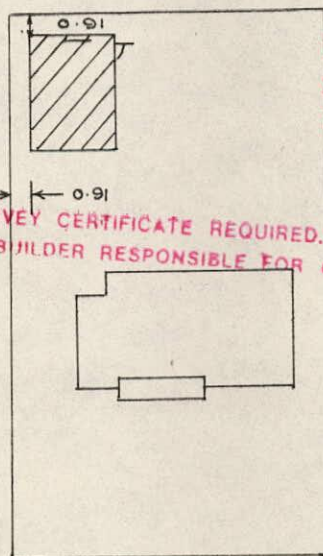
SITE PLAN.

NATURAL GROUND LEVELS AT  
SITE BOUNDARIES AND EASE-  
MENTS SHALL NOT BE ALTERED"NO SURVEY CERTIFICATE REQUIRED."  
LESSEE/BUILDER RESPONSIBLE FOR CORRECT SITINGThe proposed structure shown on this plan has  
been sited clear of the electricity service to the  
residence, and may be erected on the site indicated.

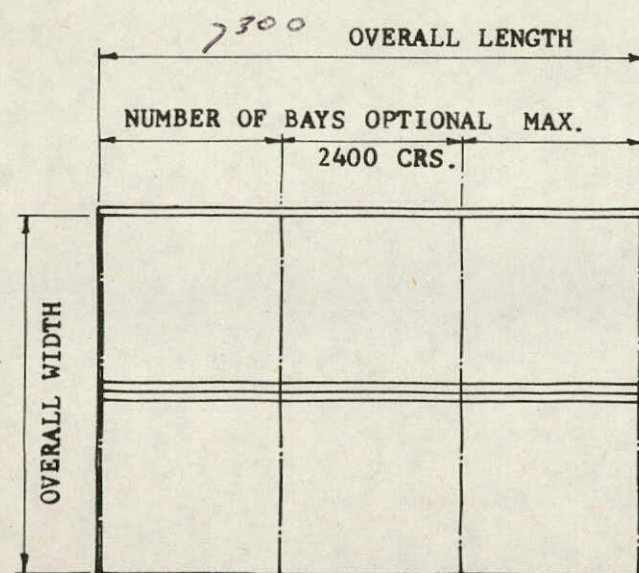
PLAN (NOT TO SCALE)

44 x 44 x 3 ANGLE  
CLEAT AT JOINT IN  
PURLINS & GIRTS -  
WHERE LENGTH EXCEEDS  
7200

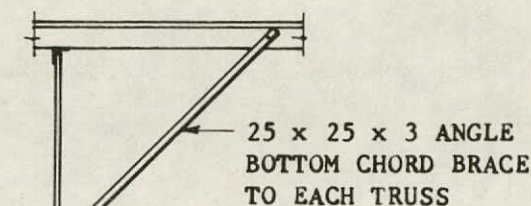
SECTION A-A HAND OPTIONAL

44 x 44 x 3 ANGLE POST TO REAR FRAME. ONE AT MID SPAN FOR SPANS TO 4800 TWO EQUALLY SPACED FOR SPANS OVER 4800 BOLT TO TRUSS

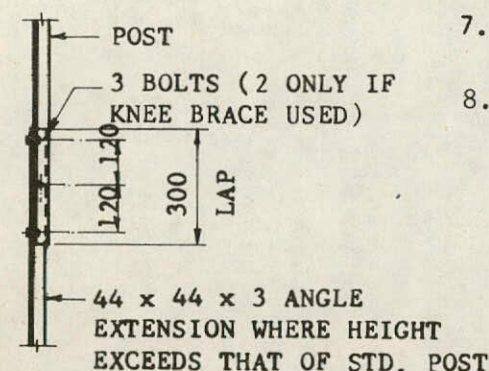
STRUCTURAL DETAILS  
WITH TRUSS CONFIGURATION  
FOR SPANS OVER 4250 TO 6000

375 SQ. INTERMEDIATE POSTS  
225 SQ. FRONT & REAR POSTS  
INCREASE AS REQUIRED TO GIVE 50 COVER OF CONCRETE OVER STEEL
