PROPERTY AT:

**56 Bertel Crescent
CHAPMAN ACT**

Pre-Purchase Inspection - Residential Building Report – (ACT)

**Complies with Australian Standard AS 4349.1- 2007 Inspection of Buildings Part 1:
Pre-Purchase inspections – Residential buildings – Appendix “C”**

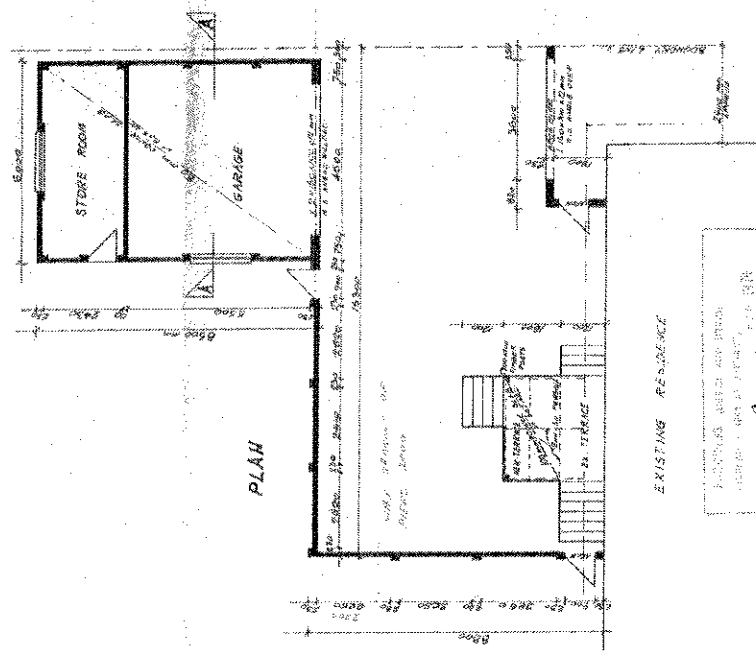
PLAN

R.H. ELEVATION
 BUILDING TO BE CONSTRUCTED
 IN ACCORDANCE WITH THE
 BUILDING MANUAL ACT, 1973
 B.A.A. CODES OR AS DIRECTED

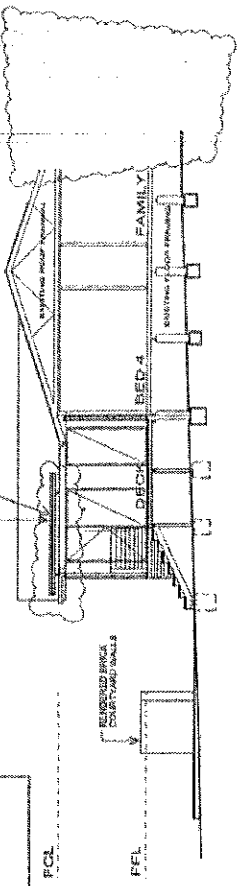
SECTION A-A

COVER FOR ROADSIDE DRIVE WITH
 STAINLESS STEEL RAILINGS

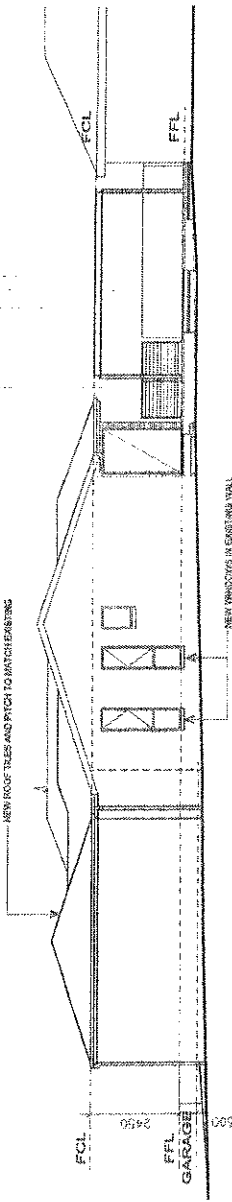
SOUTH ELEVATION

NEW ROOF TILES AND PITCH TO MATCH EXISTING

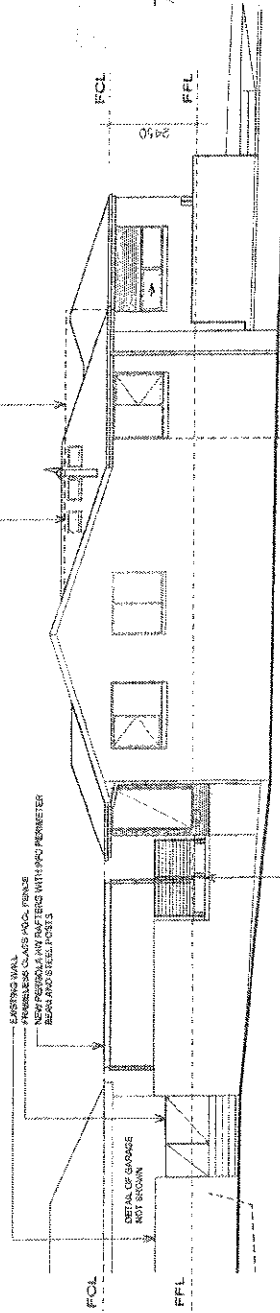
NORTH ELEVATION

NEW PERGOLA AND PATIERS WITH PFC PENNETER
 REMAINING ROOF SKIN NOT SHOWN

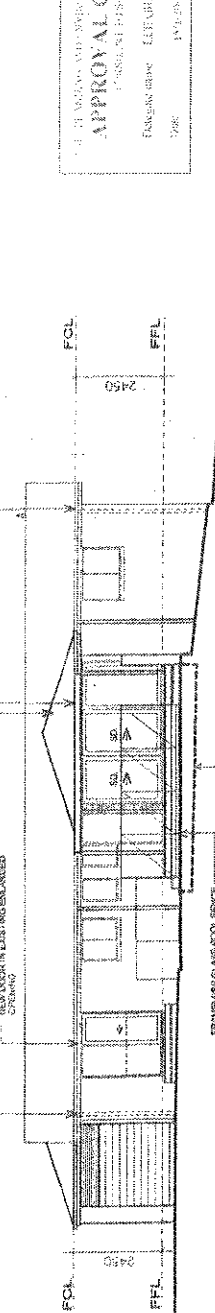
EAST ELEVATION

NEW ROOF TILES AND PITCH TO MATCH EXISTING
 NEW PERGOLA AND PATIERS WITH PFC PENNETER
 REMOVE EXISTING DOWNPIPE GUTTER

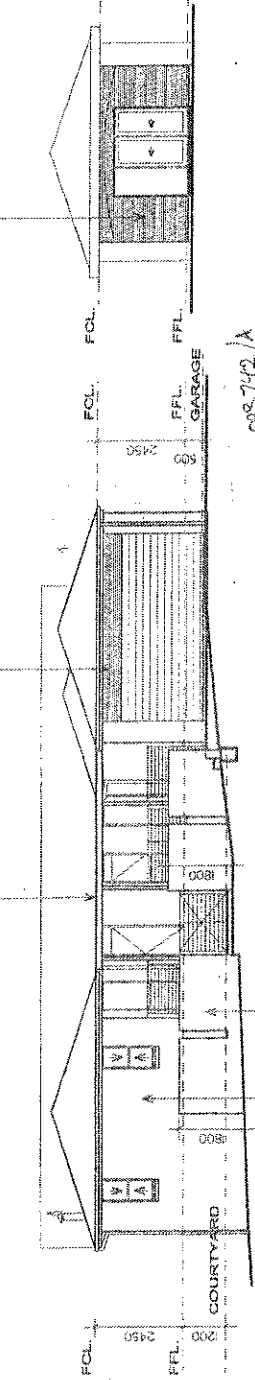
WEST ELEVATION

NEW PERGOLA AND PATIERS WITH PFC PENNETER
 REMOVE EXISTING DOWNPIPE GUTTER

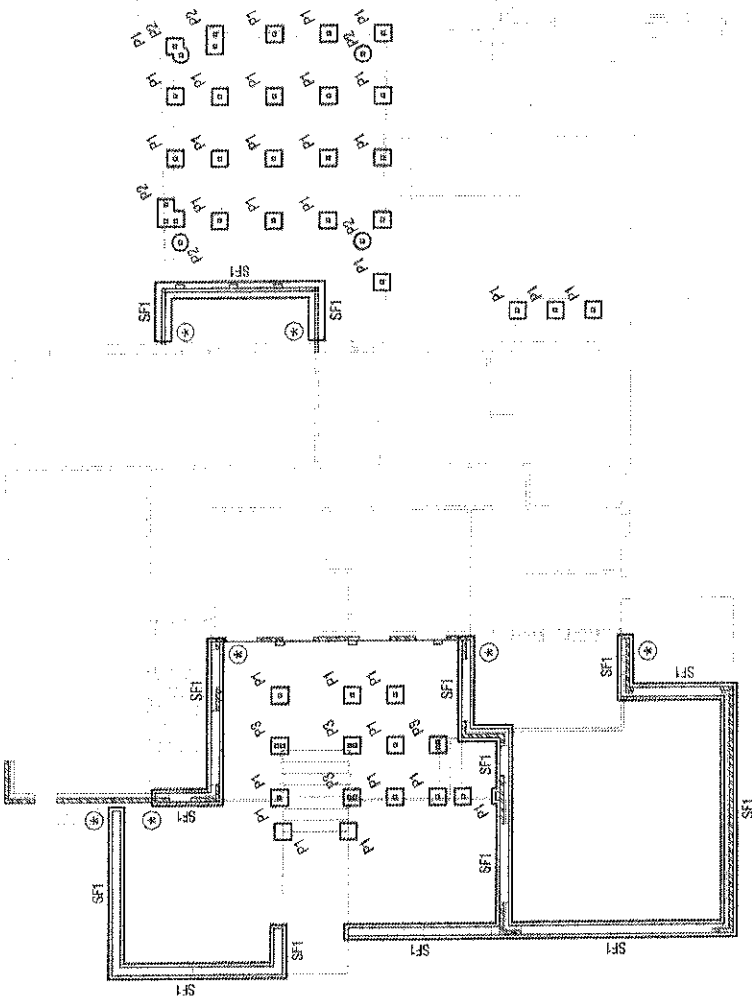
Footing Plan

- Pad footings P3 to be joined P1's to receive double piers / posts
- No existing footings shall be undercut during new work. If the underside of footings are exposed an engineer shall be called to assess the situation and provide the necessary details before work continues.

- Concrete to footings grade N20.
- No walls are to act as retaining walls unless constructed in accordance with the detail of the typical masonry gravity retaining walls. Refer to standard detail. Note all walls retaining earth to be backfilled with washed river gravel over an agricultural drainage connected to the SW system.

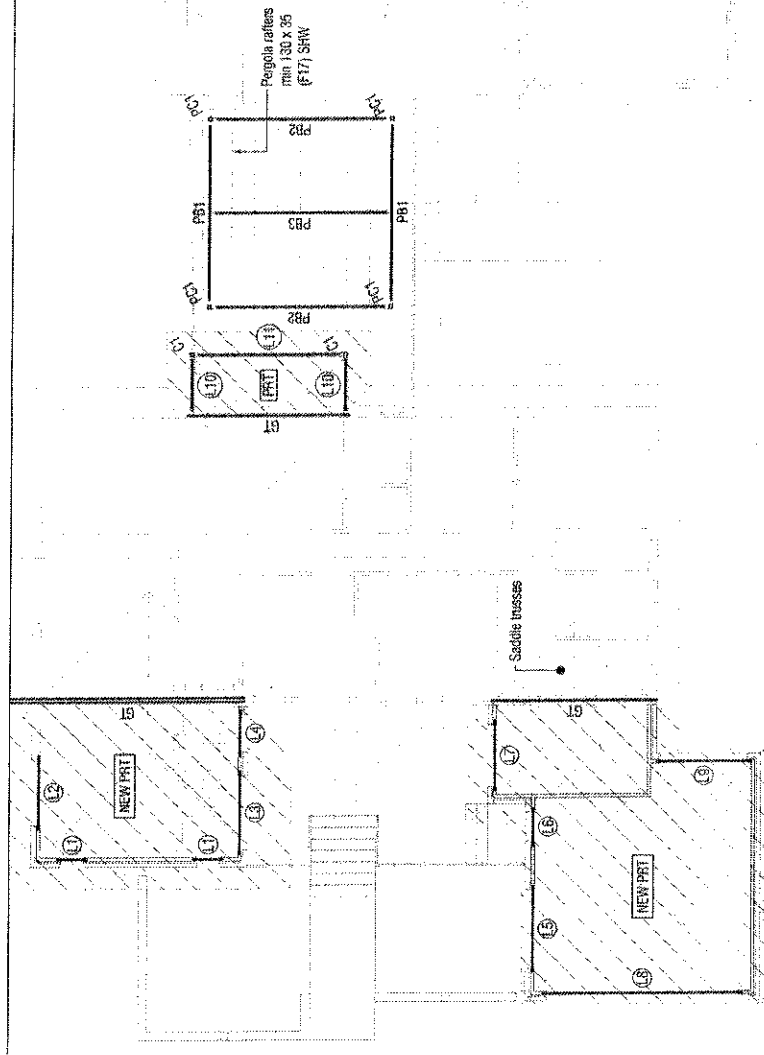
- Walls shall be framed in accordance with the requirements of AS 1684.
- Unless noted otherwise use double studs nailed together at 300mm c/c to flank all openings.
- Build into the stud walls SHS columns where noted on the plans. Power fix studs to adjacent in-situ SHS columns at 450mm c/c.
